# Manhole Inspection Summary

Manhole # S25G\_\_023MH

Insp Date: **8/30/07 8:34 AM**

**Location** Address: **1201 CARROLLTON AVE** Cross Street: **BALTIMORE ST**

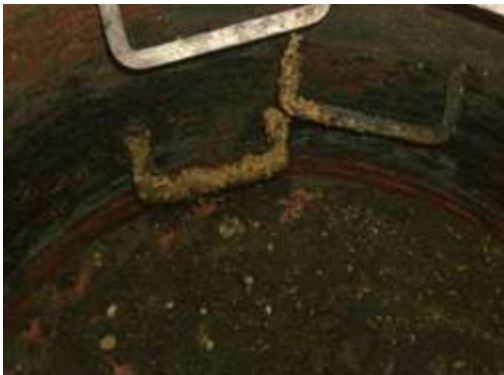
Defect 4

**Surcharge** ☒ **Evidence Of Surcharge** Depth: **3** (ft.) ☐ Active Surcharge Present

SURCHARGE EVIDENCE ON THE  
BOTTOM 2 STEPS

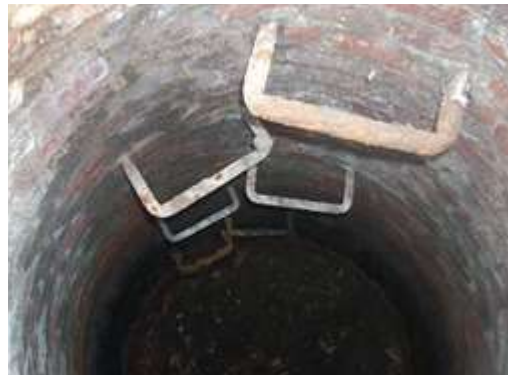
Defect 3

**Steps** Count: **6** Missing: **0** ☒ **Corroded**

CORRODED STEPS

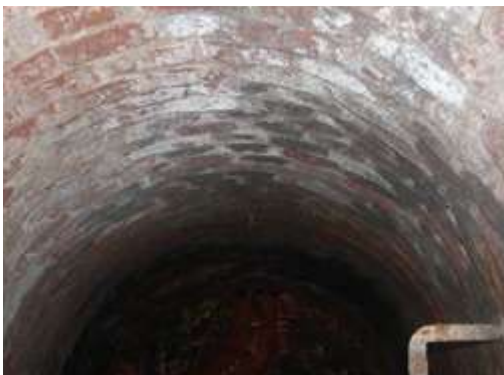
Defect 2

**Barrel** Material: **Brick** ☐ Parged  
Shape: **Circular** Diameter: **48** (in.) Length: (in.)  
Condition: ☒ Sound ☐ Cracked ☐ Root Intrusion ☐ Loose Brick ☐ Deteriorated  
Infiltration: ☐ None ☐ Joint ☐ Cracks ☐ Mortar ☐ Roots ☒ **Wall**

INFILTRATION OF THE BARREL WALL

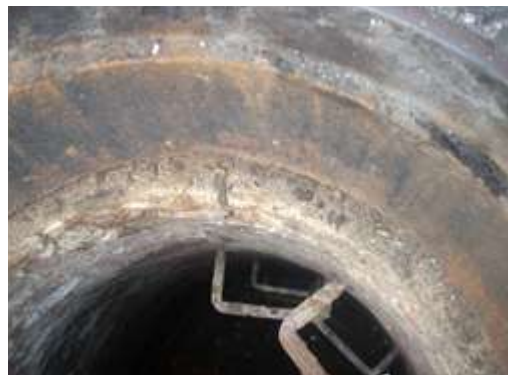
Defect 1

**Frame** Offset: **2** (in.) Condition: ☒ Sound ☐ Cracked ☐ Leaks

FRAME OFFSET

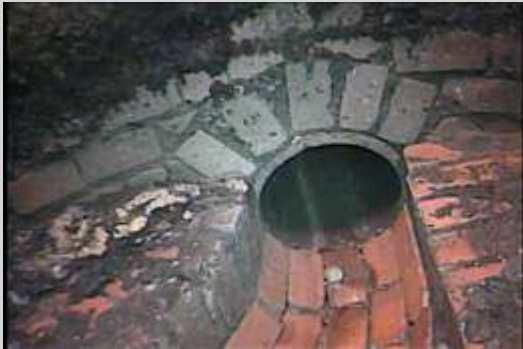
12 O'Clock Outflow

Pipe Height: **8.4** (in.) Rod and Bar (Angled)  
Pipe Material: **Clay** ☐ Pipe Lined  
Invert Depth: **10.61** (ft.) Flow Characteristics: **Slow**  
Deposits: ☒ None ☐ Mud ☐ Sludge ☐ Debris ☐ Grease  
Silt Depth: (in.) Deposits Extent:  
Infiltration: **None** Pipe Seal Cond: **Sound**

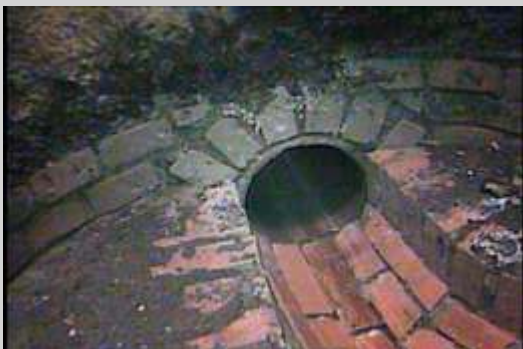
9 O'Clock Inflow

Pipe Height: **8.4** (in.) Rod and Bar (Angled)  
Pipe Material: **Clay** ☐ Pipe Lined  
Invert Depth: **10.49** (ft.) Flow Characteristics: **Slow**  
Deposits: ☒ None ☐ Mud ☐ Sludge ☐ Debris ☐ Grease  
Silt Depth: (in.) Deposits Extent:  
Infiltration: **None** Pipe Seal Cond: **Sound**
